In-Place Strength Evaluation of Existing Fixed Offshore Platform Located in Persian Gulf with Consideration of Soil-Pile Interactions

located in the Persian Gulf. The platform is now 47 years old and the objective of the study is to verify whether the platform can meet the structural requirements, as per API RP 2A and AISC. To check if it is fit for purpose for a life extension of 20 years beyond 2016. To provide a more exact and effective evaluation of offshore pile foundation systems under axial functional loads and lateral environmental loads, a finite element model software (SACS) is employed to consider the pile soil interaction. It should be noted that the structural model is based on the best estimates of the existing conditions of the platform.

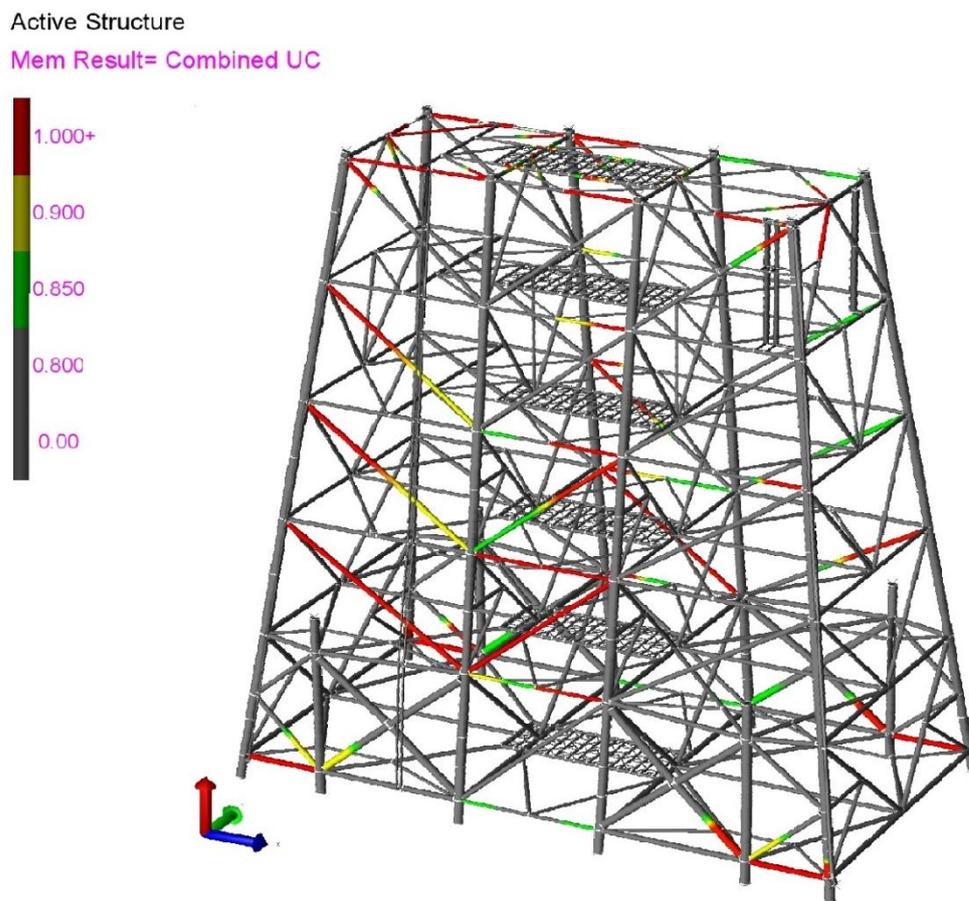
Figure 2: 3D Model for Jacket Members with UC >1.0

A member check of a frame's structural member is performed to assess whether the member is subjected to acceptable stress levels. Calculation results show that under 100-year storm load condition, a total number of 44 members have had stress utilization factors (UCs) greater than unity. 24 members are located in the splash zone of the platform. They are believed to suffer from serious corrosion. Five critical members are secondary beams in main deck that are affected by local loading of equipment. These members have poor section (channel and angle sections) which seems have not sufficient section for local loadings and need to be reinforced or stiffened. Figure 2 presents the graphical summary on the whereabouts of code-noncompliance members identified in the course of the assessment analysis in existing condition.

A punching shear check is carried out on the brace member at a joint to assess the shear through the chord. As for the other checks, these assessments are made through the use of a punching shear interaction equation that delivers a usage factor. A total number of 52 joints have had utilization factors (UCs) greater than unity. A lot of these joints are located in splash zone.
